## Constructed wetlands need attention or else they fail

Dr Kevin Winter  
UCT Urban Water Management Research Unit

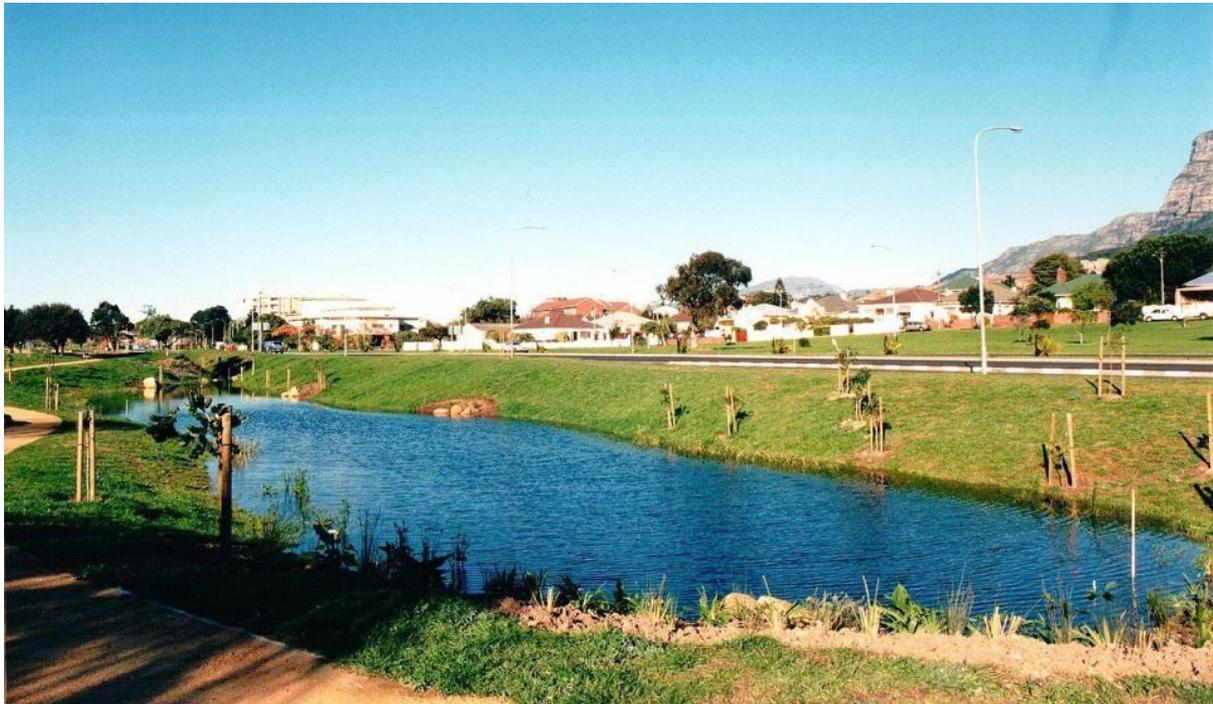
Newly constructed wetland adjacent to the Liesbeek River. Photograph taken by Douglas Metcalfe in 1997 soon after the project was completed.

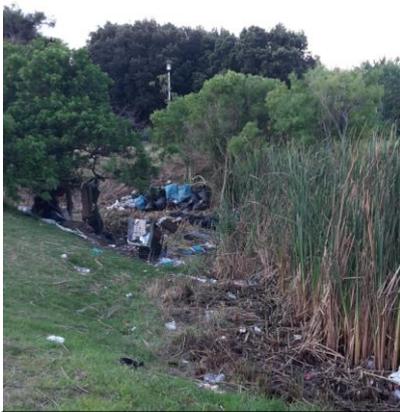
from the Liesbeek River, the soils in wetland began accumulating excess nutrients from stormwater runoff. All the ingredients were in place to change a once pretty wetland into a maintenance problem and a public eyesore. Phragmites reeds took over the wetland, as they do in shallow wetland systems throughout the Western Cape – an indication that they were thriving on the nutrients and actually doing a great job in absorbing pollutants. The familiar sight of a bunch of common reeds is hardly an attractive environment. The public were more displeased when these overgrown areas become the refuge for the homeless along with the excessive litter and general grim that accompanies those living in these conditions. Social factors are integral to understanding constructed wetlands are used and abused, and require dedicated management. It is also important to acknowledge that this wetland did and continues to absorb stormwater contaminants from a section of a formal residential area of Mowbray. The wetland is working, but just as it is being loaded with visible litter largely from homeless people, it is being loaded by contaminated water that is largely unseen.

The wetland (20 October), first efforts to remove the reeds (again) exposing the litter

It is possible that the City and residents have reached a critical point. The question is being asked: what can be done now? It could be managed but in this case it is likely to fail because dedicated management is unlikely, too costly and probably not worthwhile in the bigger scheme of things. Perhaps an alternative design should be considered – one that is less maintenance intensive, looks good and continues to deal with the contaminated, runoff that often has elevated temperatures.

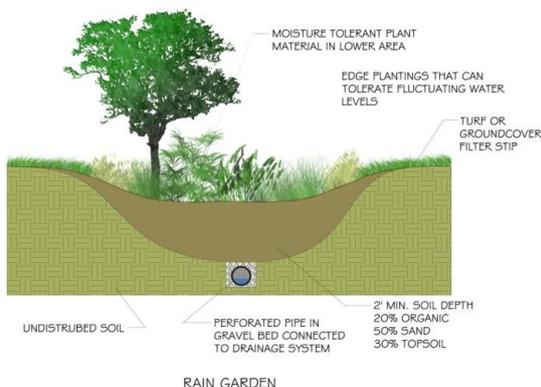
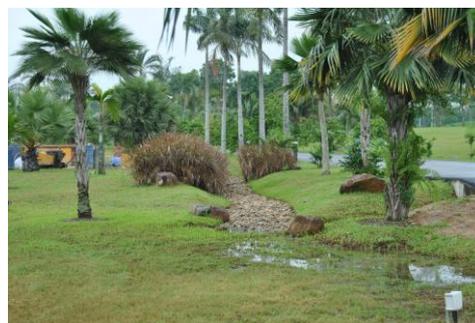
*Some ideas – creating a rain garden; drawing water to the surface; runoff over shallow, cobbled channels*

- (a) How can we store and use the runoff as a water source?
- (b) How can we design a system that cleans the water?
- (c) How can we cool the water temperature down to similar temperatures as to that of Liesbeek River?
- (d) How will the design contribute to a sense of place? It is a well-used public walkway but the attraction is missing.
